## SENSOTEQ KAPPA X TRIAL

- Technical management JPS Reliability Ltd
- **Kappa X Wireless Sensor** (Developed by Sensoteq and RMS)

# Sensotek Kappa X Trial

The screenshot displays the Sensotek Analytix web interface for a specific asset: **BL2 Dryer Fan Zone 1 right hand side**, which is marked as **Critical**. The interface is divided into several key sections:

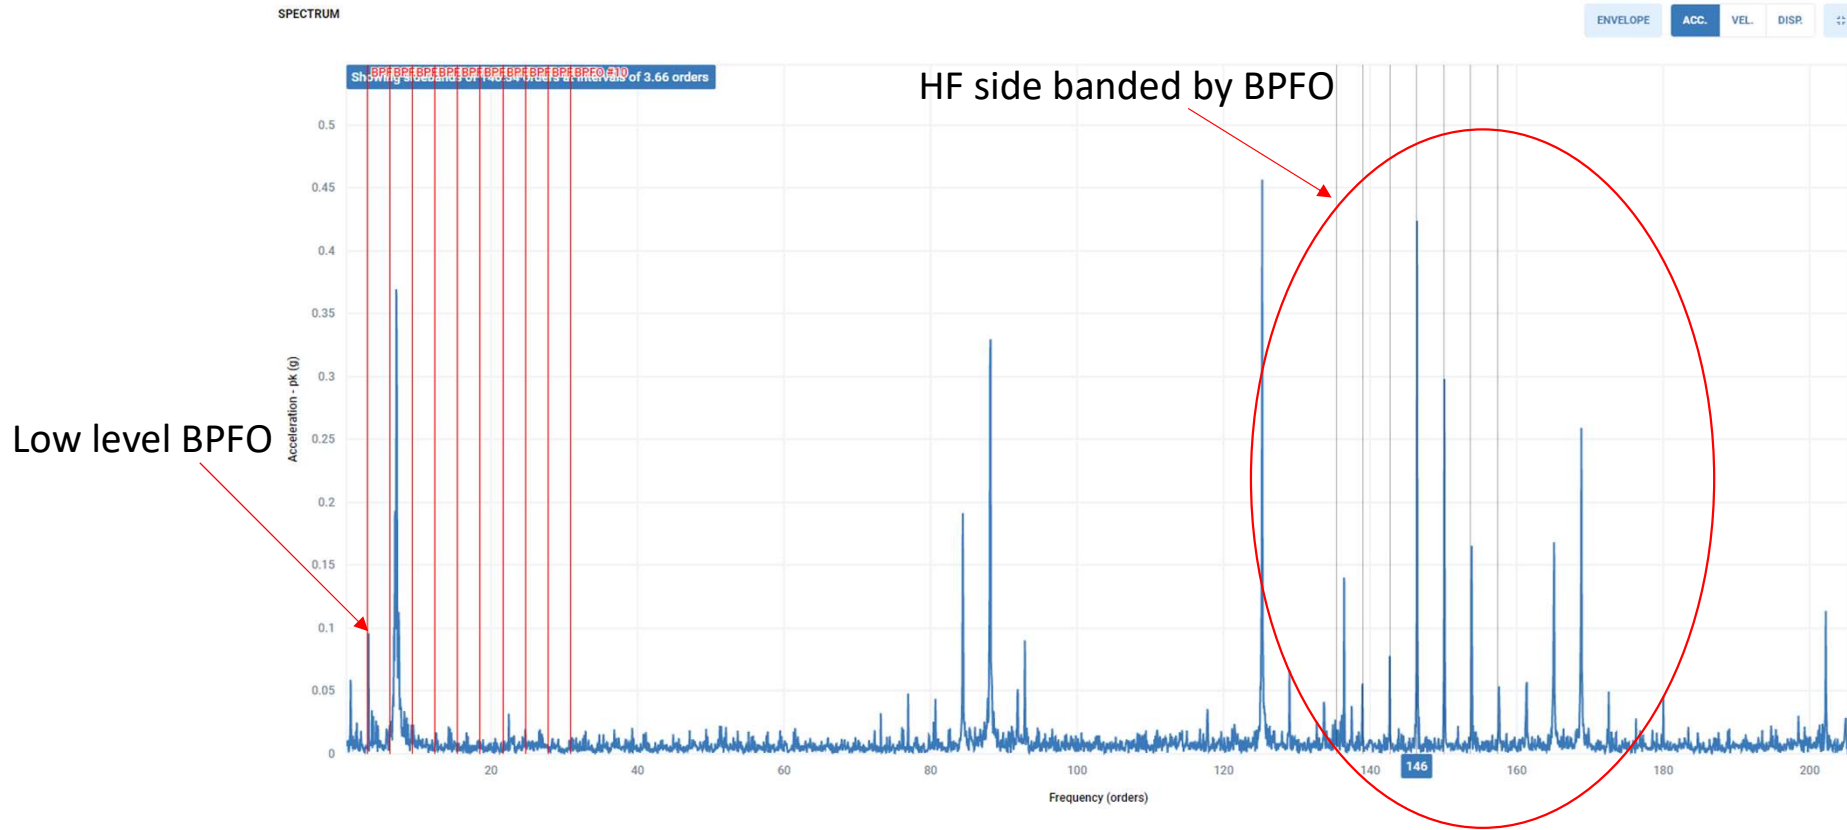
# Acceleration spectrum – sings of BPFO due to VSD

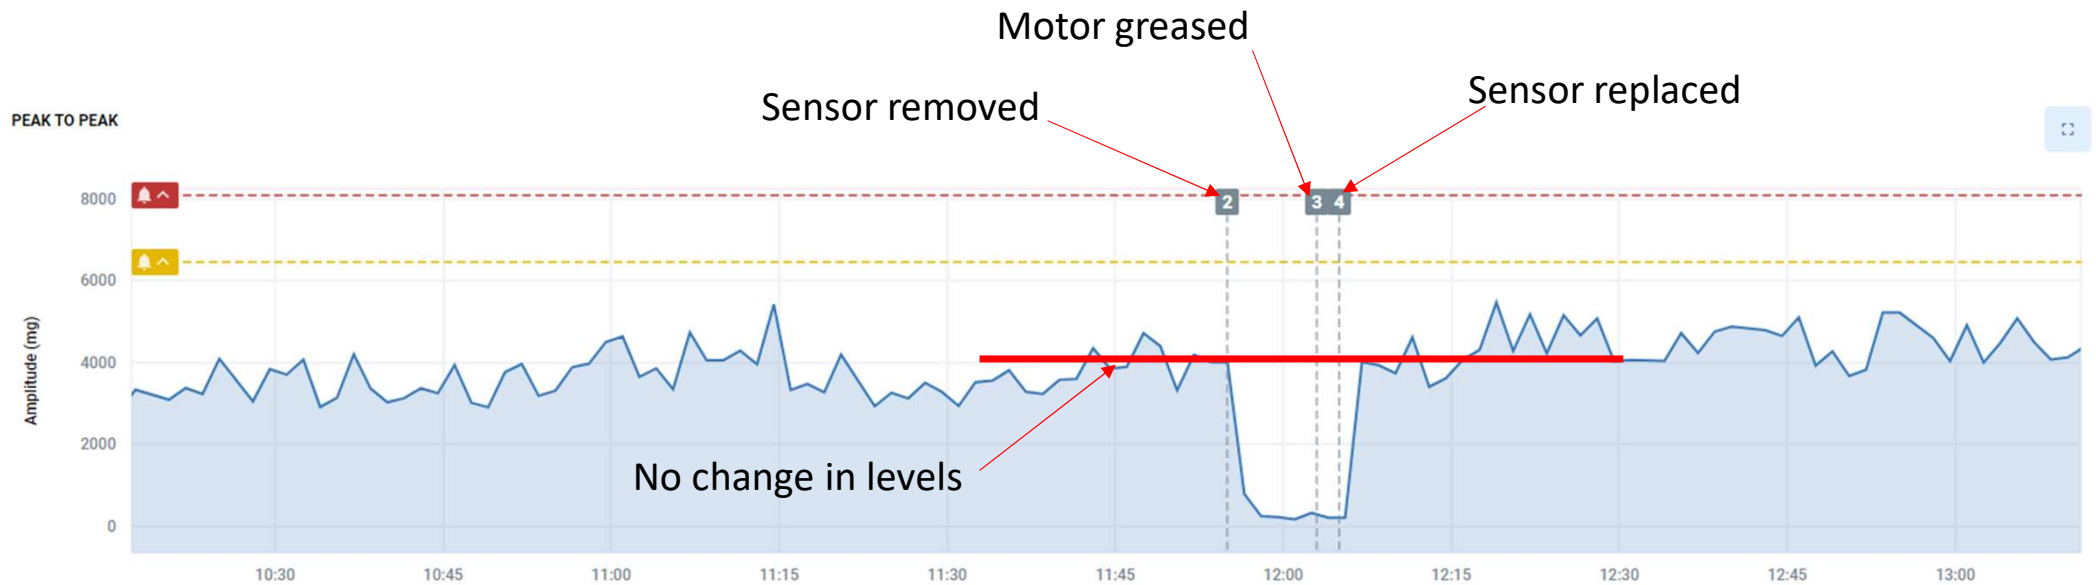
# Motor NDE

No change in the dB on greasing – No change in the VA data

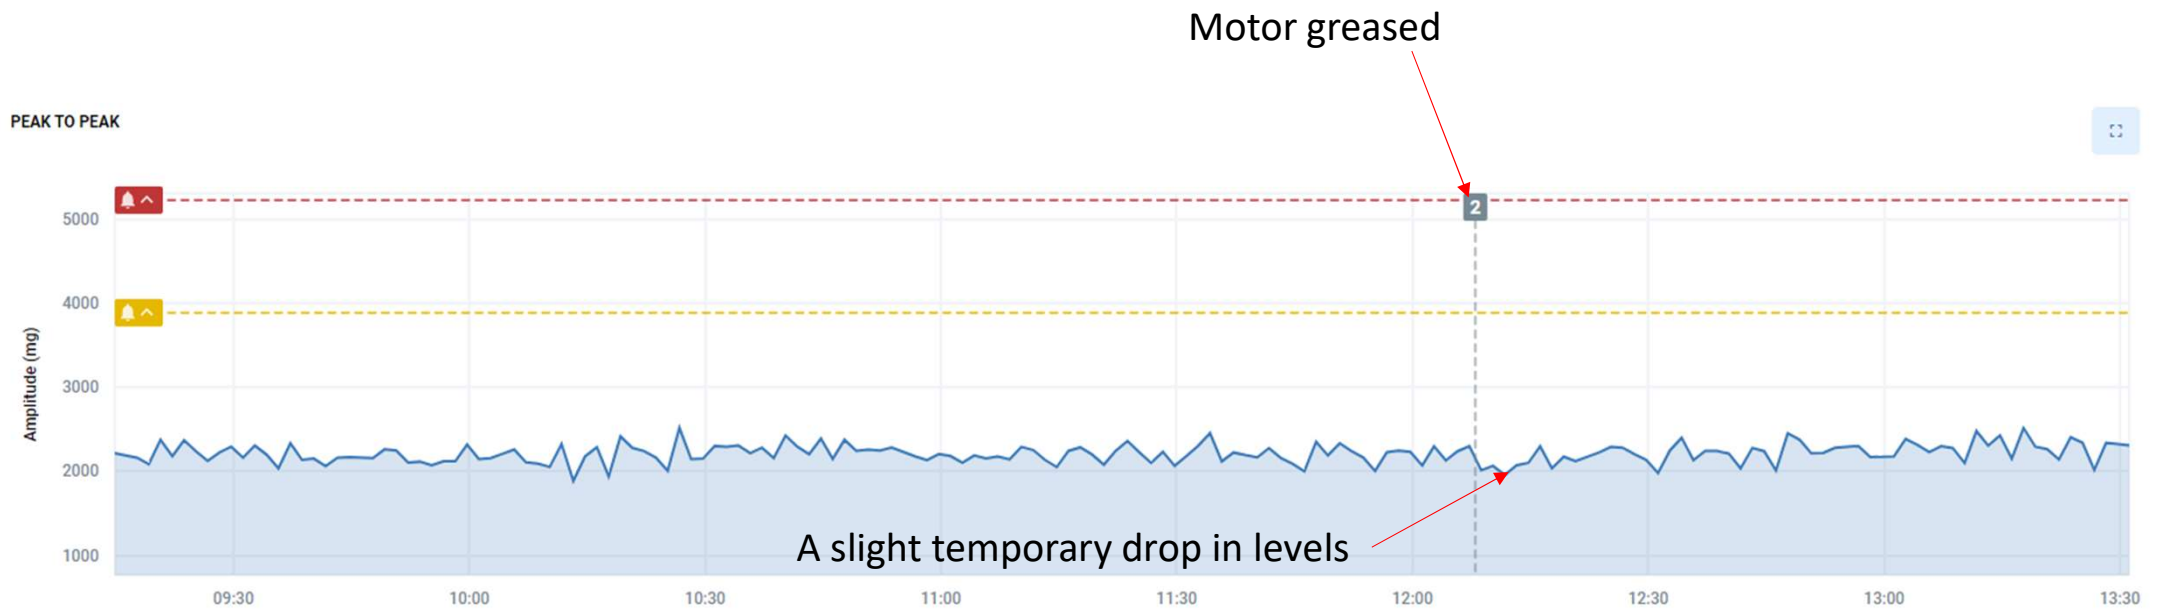
# Motor DE

43dB to 33dB on greasing – Slight temporary change in the VA data

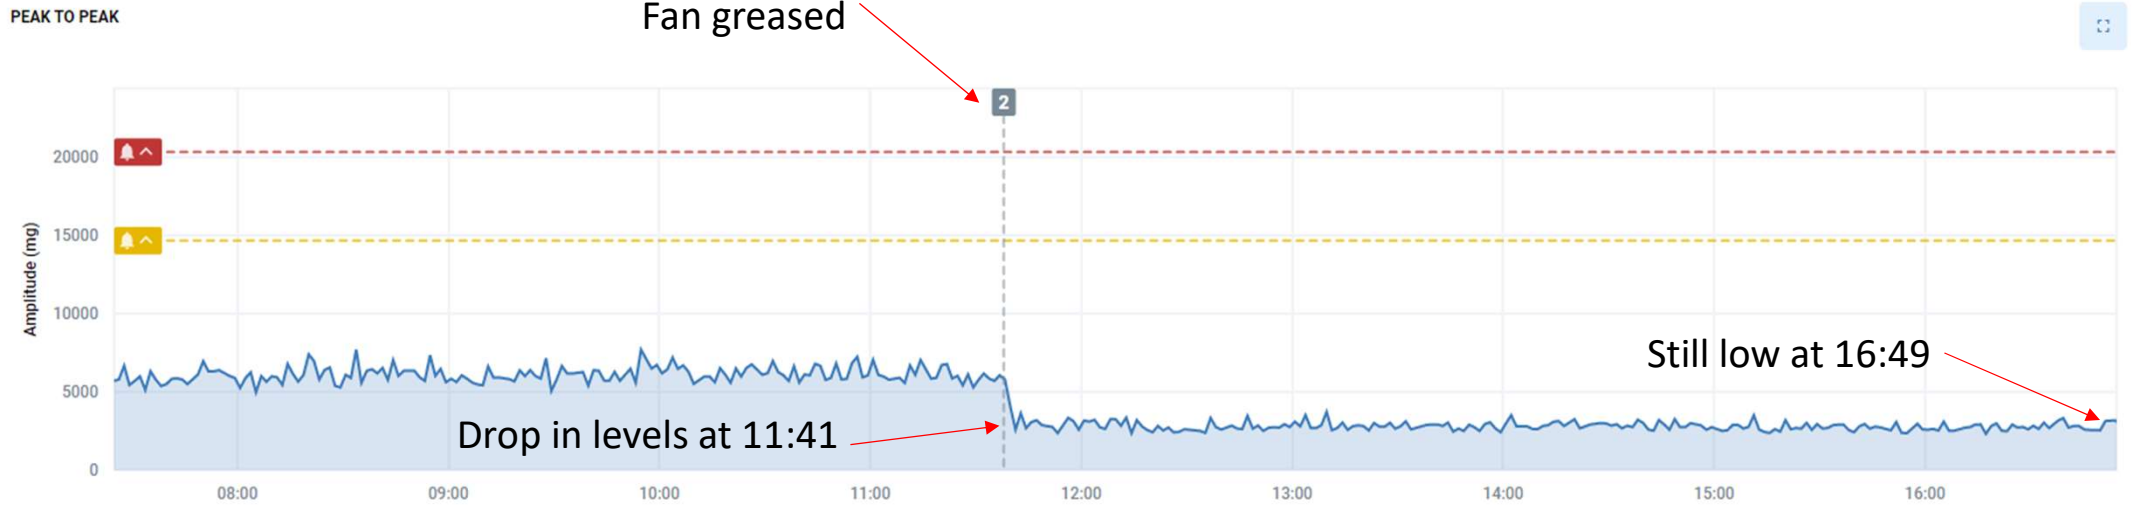
# Fan DE

58dB to 34dB on greasing – Drop in the VA data

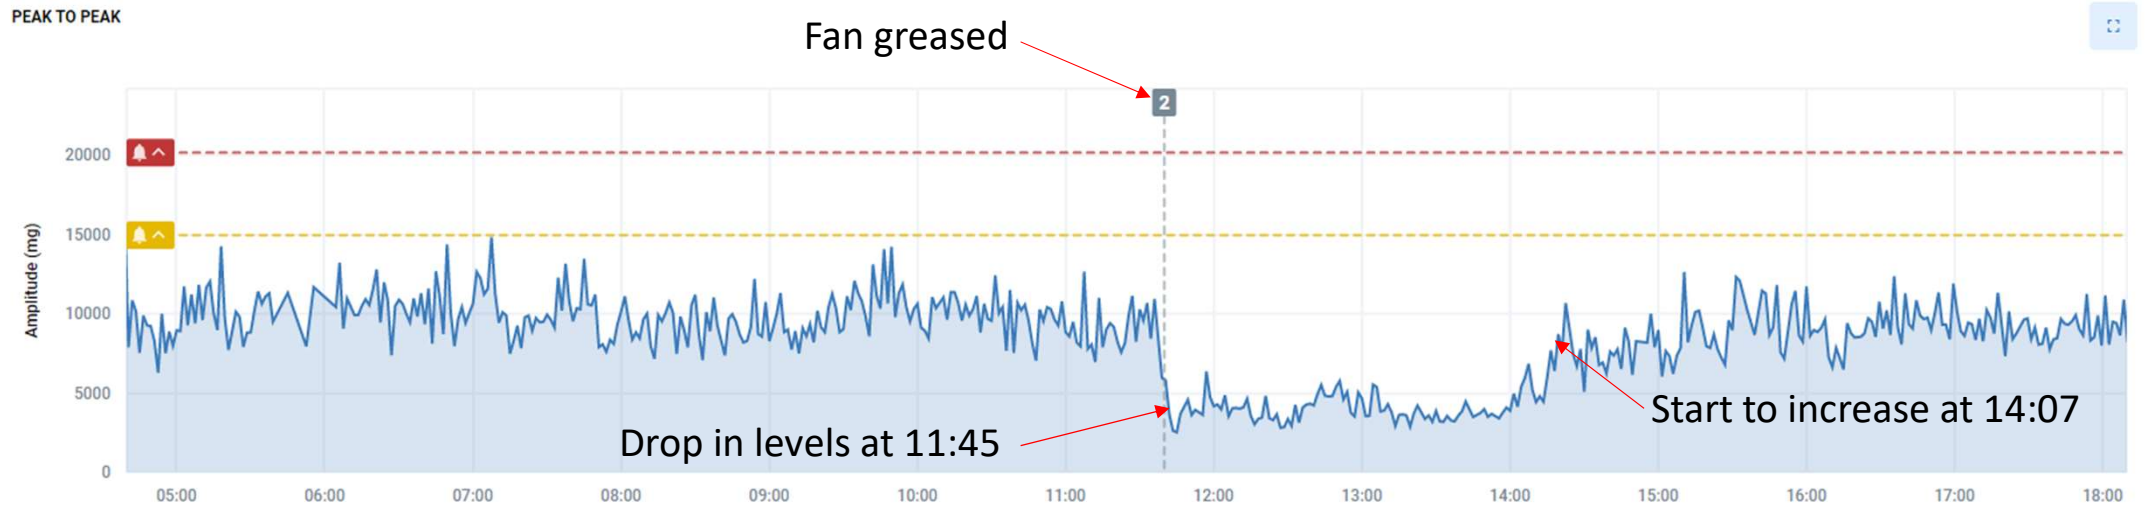
# Fan NDE

53dB to 34dB on greasing – Drop in the VA data for just over 2 hours

1. Manual temperature comparisons show that the wireless sensors have the same pattern of temperature levels.
2. The wireless system is very sensitive and can detect temperature and vibration changes on lubrication.
3. Inspection of the Fan bearings required.

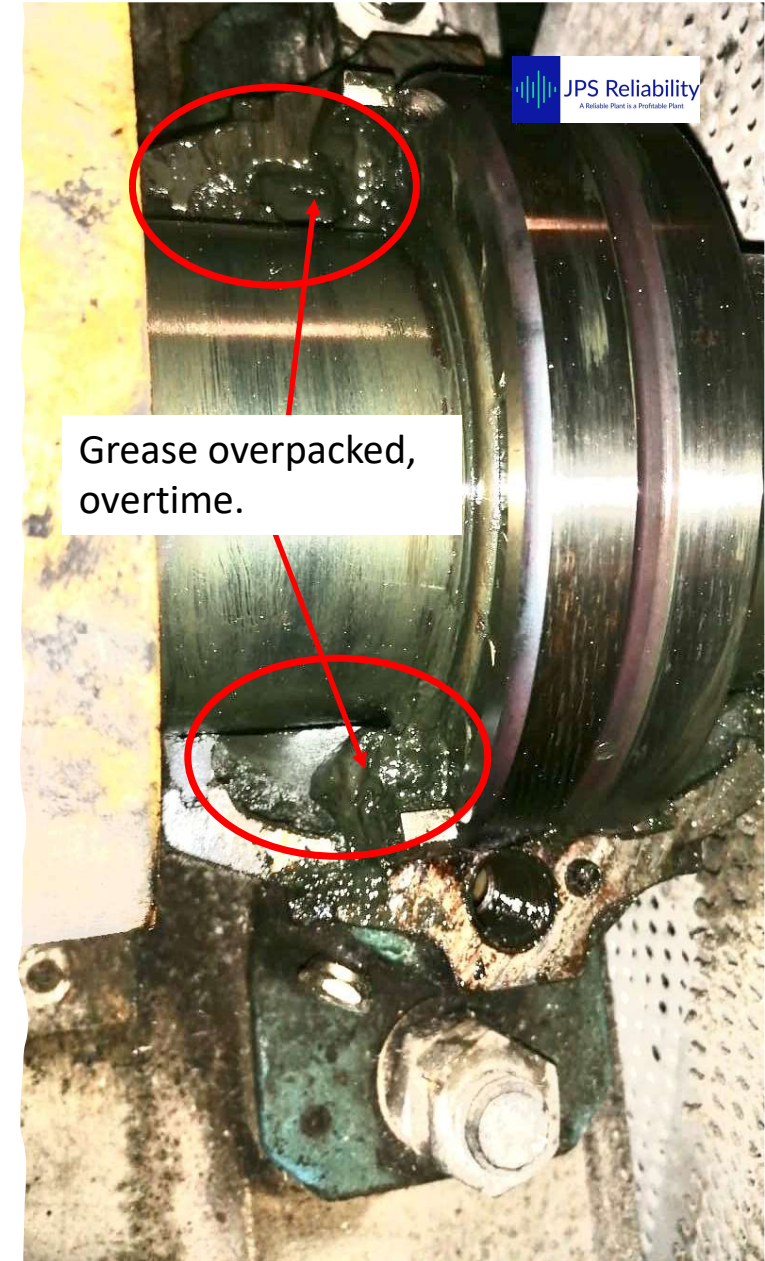
# DE Fan Bearing

Bearing overpacked with grease.

This bearing the Acceleration levels reduced but the bearing temperature increased and remained high.

- The first on the run greasing of the fan bearings had very little affect on the NDE, on the DE it reduced but the bearing temperature increased
- After bearing inspection it was found that both bearings were packed with old grease, this was removed
- After re-pack the NDE was at the lowest recorded levels, the DE however increased but then reduced back dow (probably as the grease was moving/settling in the bearing)
- Further controlled greasing of the DE fan bearing only

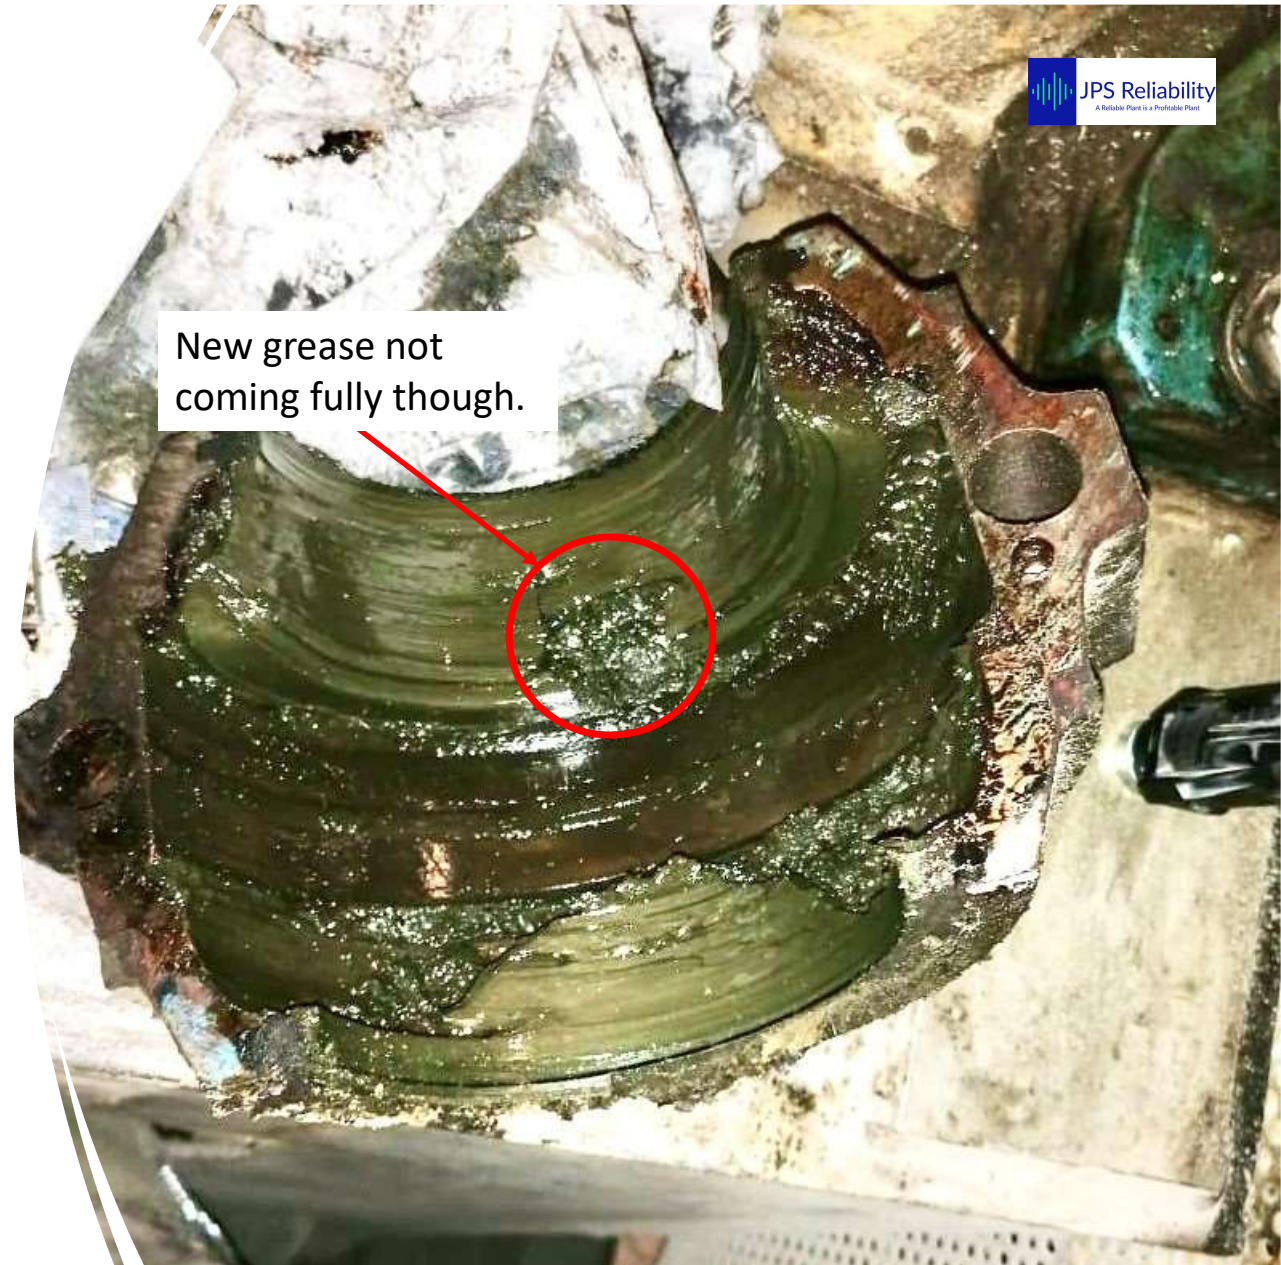
# NDE Fan Bearing

Bearing overpacked with grease.

With grease the levels only reduced temporary.

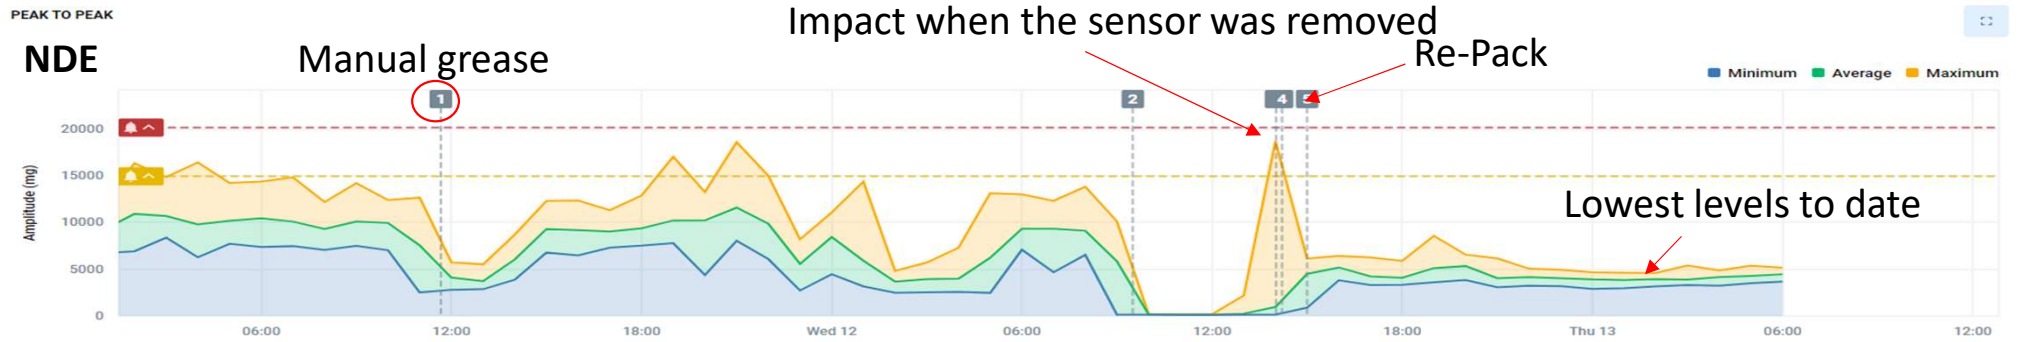
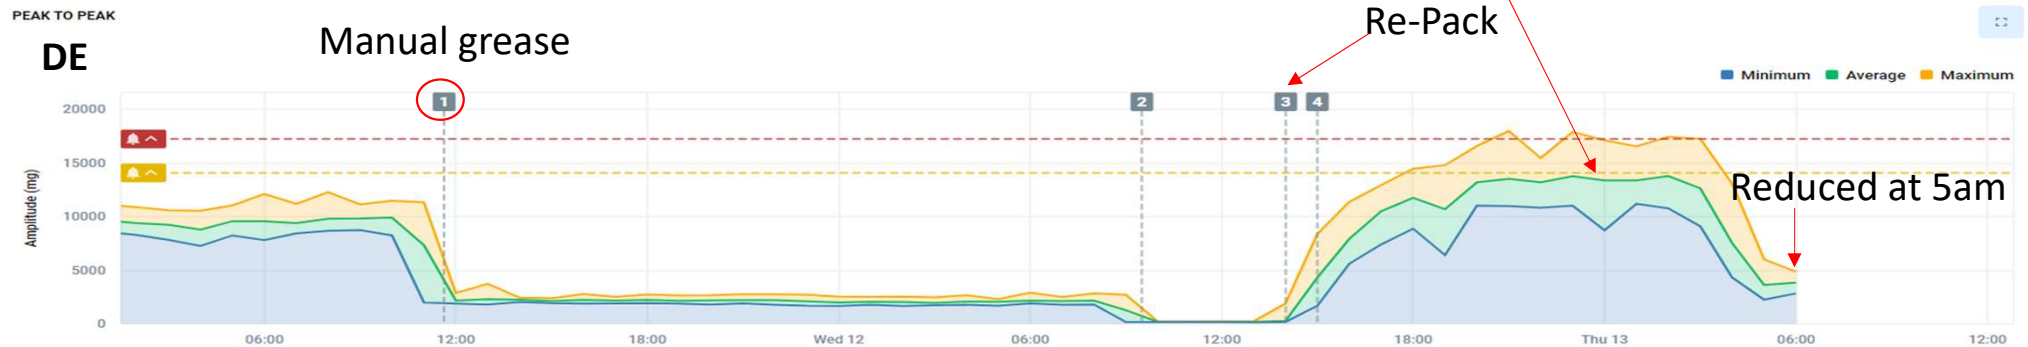
# Fan DE and NDE Comparisons

- The Fan NDE has remained at the lowest record levels
- The Fan DE had a peak increase in Acceleration and at 5am started to settled back down

- Using the ultrasound test the fan bearings to confirm if the DE has enough grease after clean out and repack
- The fan DE bearing was greased only

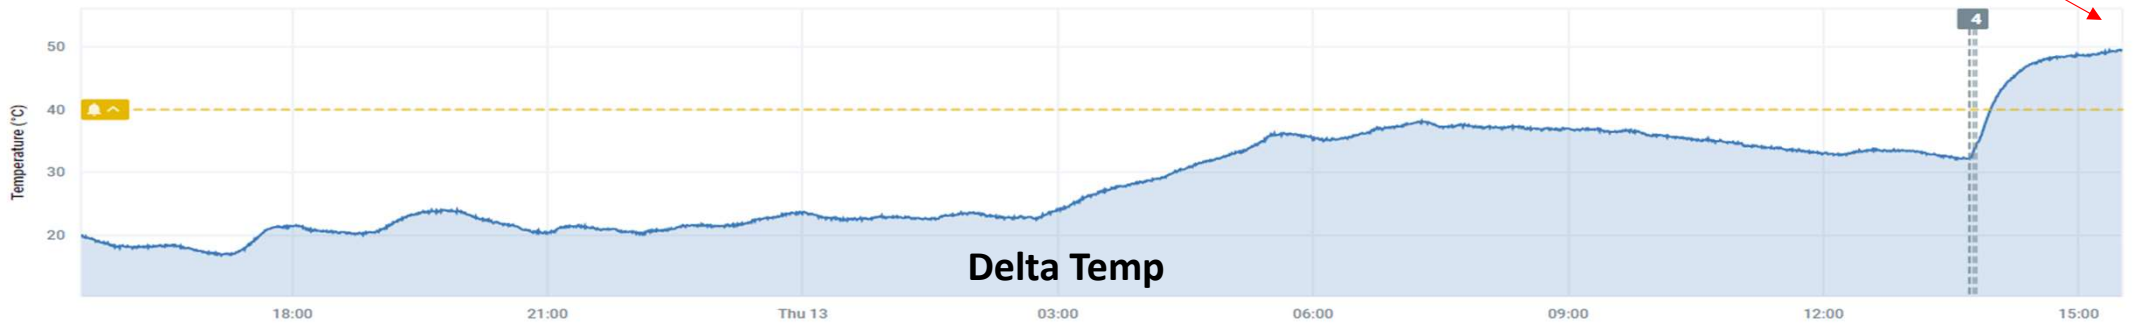
Temp steady increase with greasing

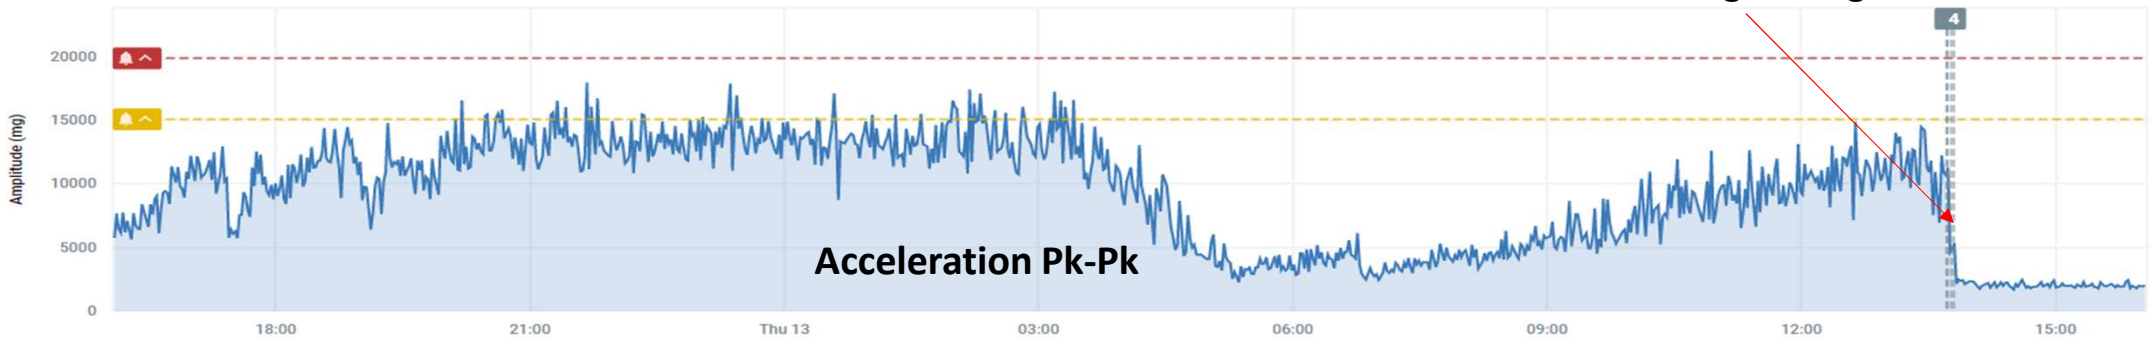
Acceleration instant reduction with greasing

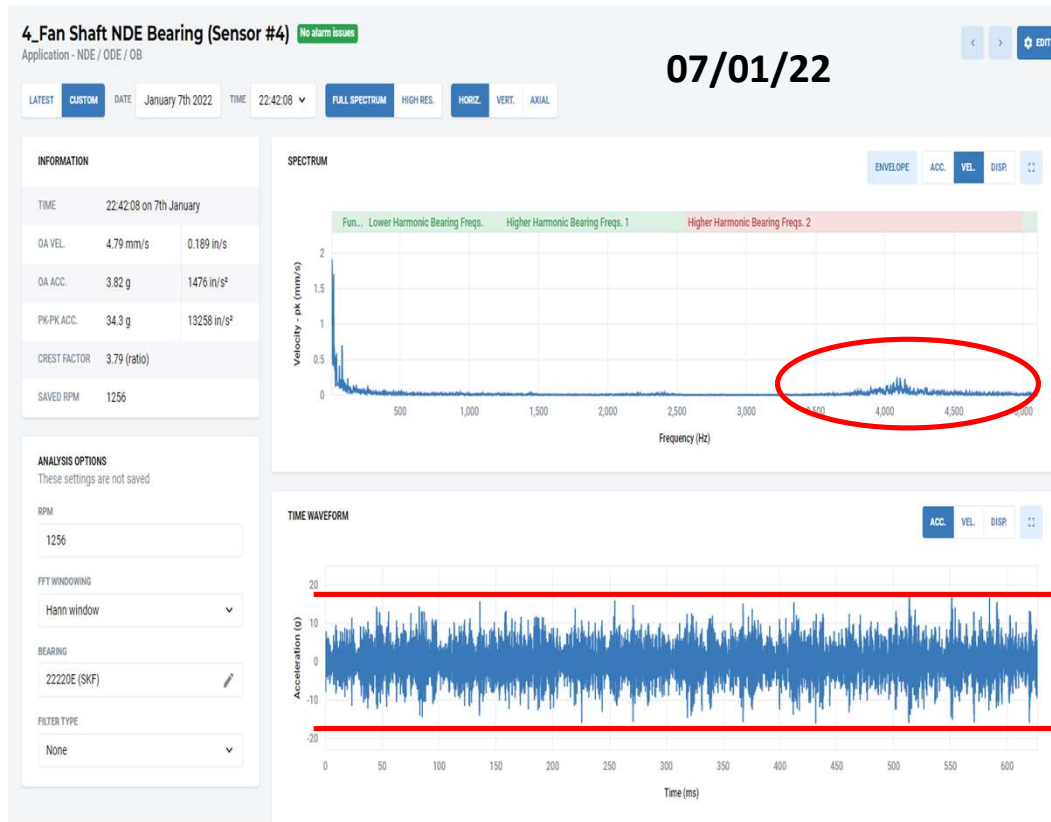
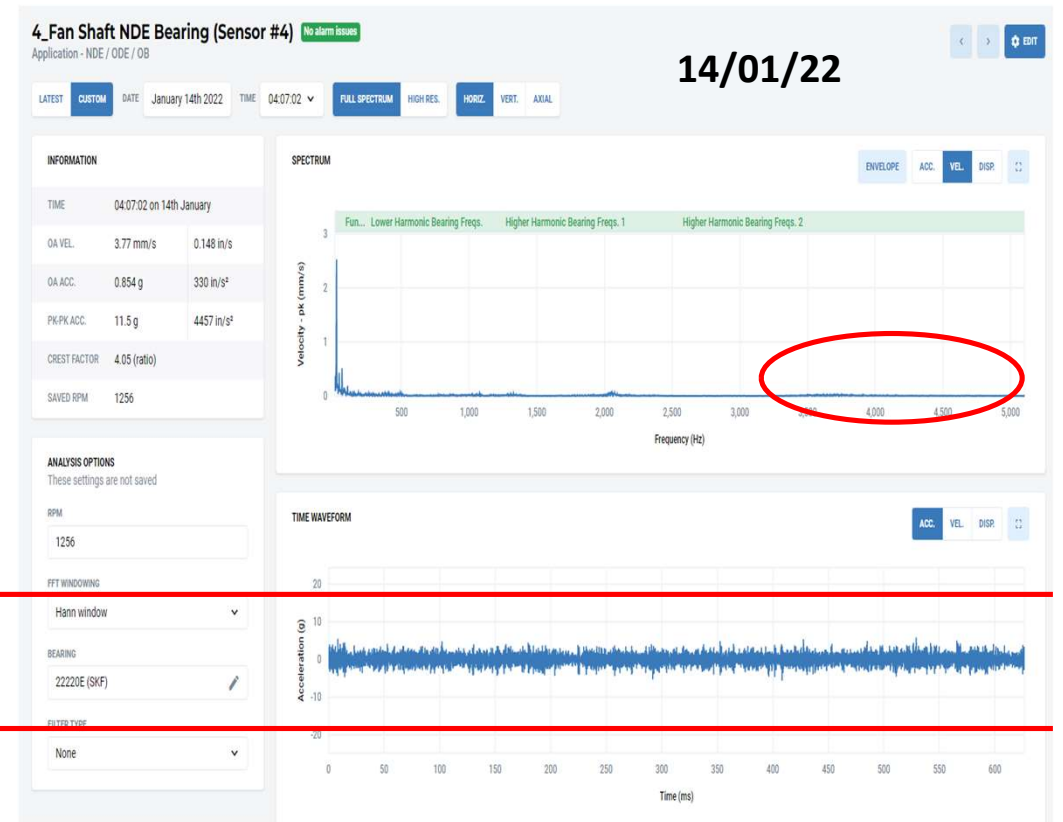
# Fan NDE bearing of Concern

Fan: The Fan NDE bearing shows signs of general bearing wear. Corrective actions has helped to reduce the bearing stress levels.

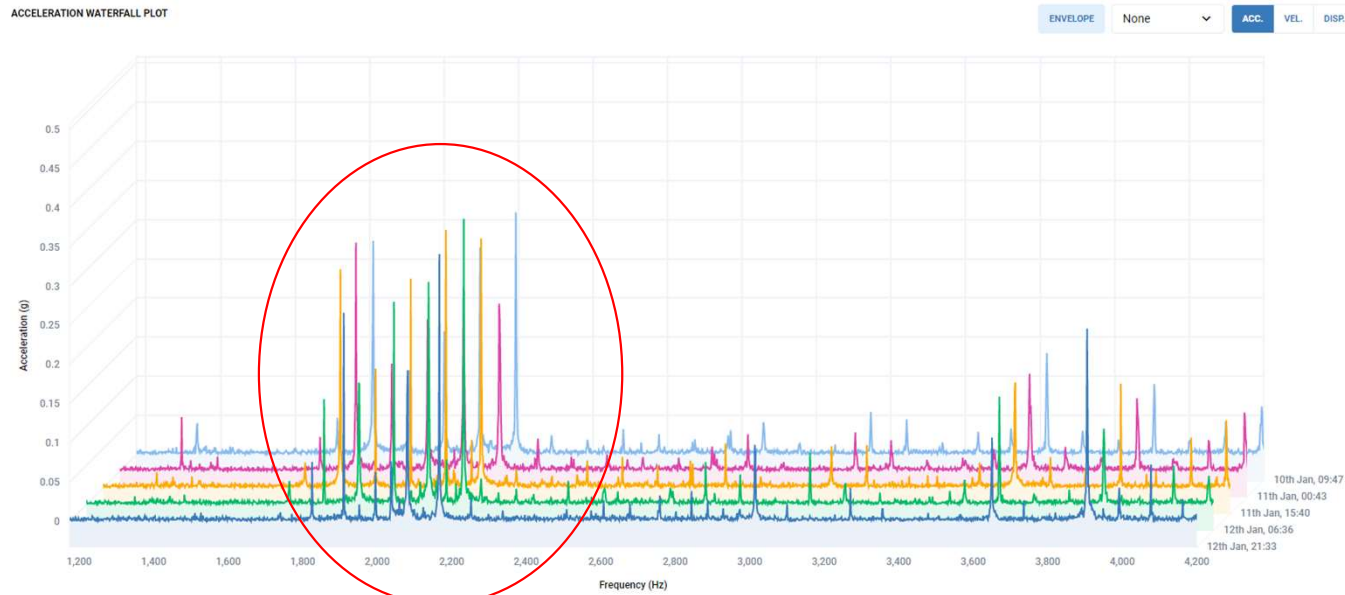
Here we can have a waterfall highlighting the electrical activity on the motor due to the VFD.

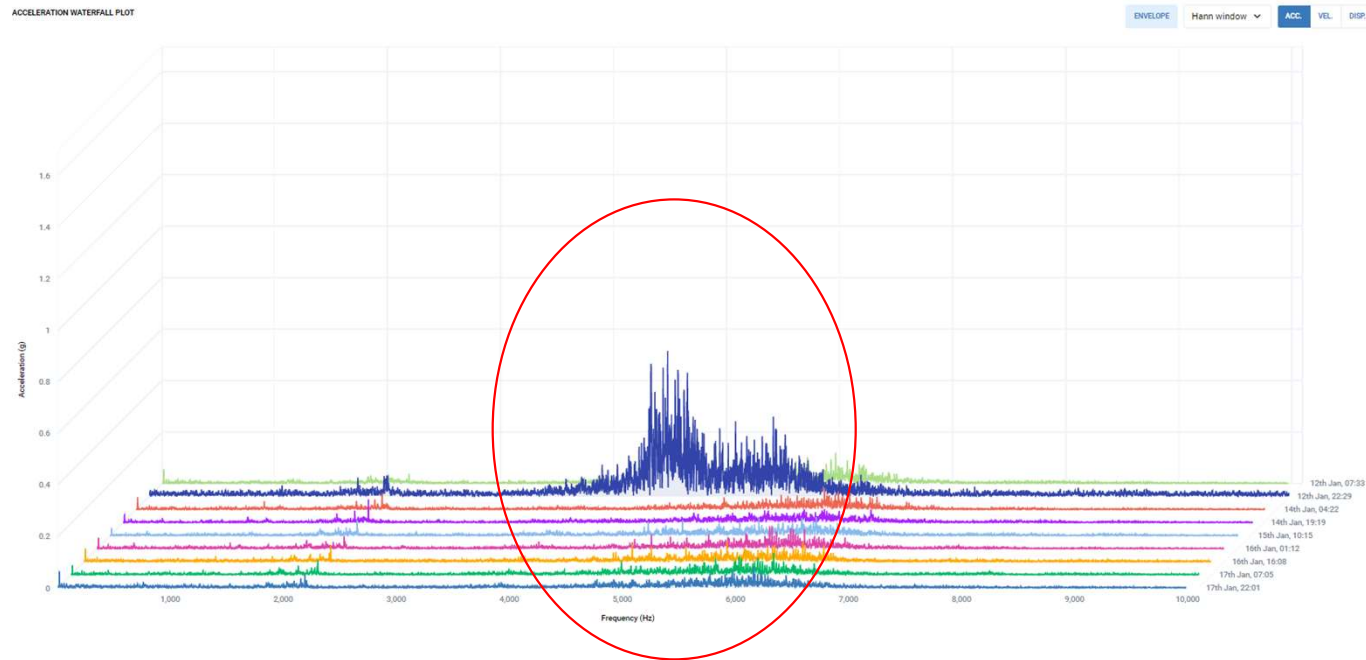
Here we can have a waterfall highlighting the high friction then reduction after greasing

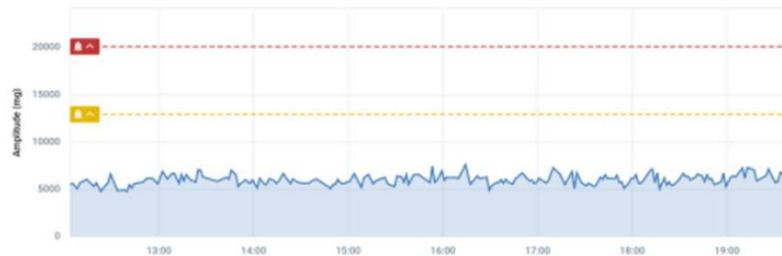
This is the fan DE bearing Pk-Pk Trend every 3 mins showing a steady 6-7 gs
