## SENSOTEQ KAPPA X TRIAL

- Technical management JPS Reliability Ltd
- **Kappa X Wireless Sensor** (Developed by Sensoteq and RMS)

# Sensotek Kappa X Trial

The screenshot displays the Sensotek Analytix web interface for a specific asset: **BL2 Dryer Fan Zone 1 right hand side**, which is marked as **Critical**. The interface is divided into several key sections:

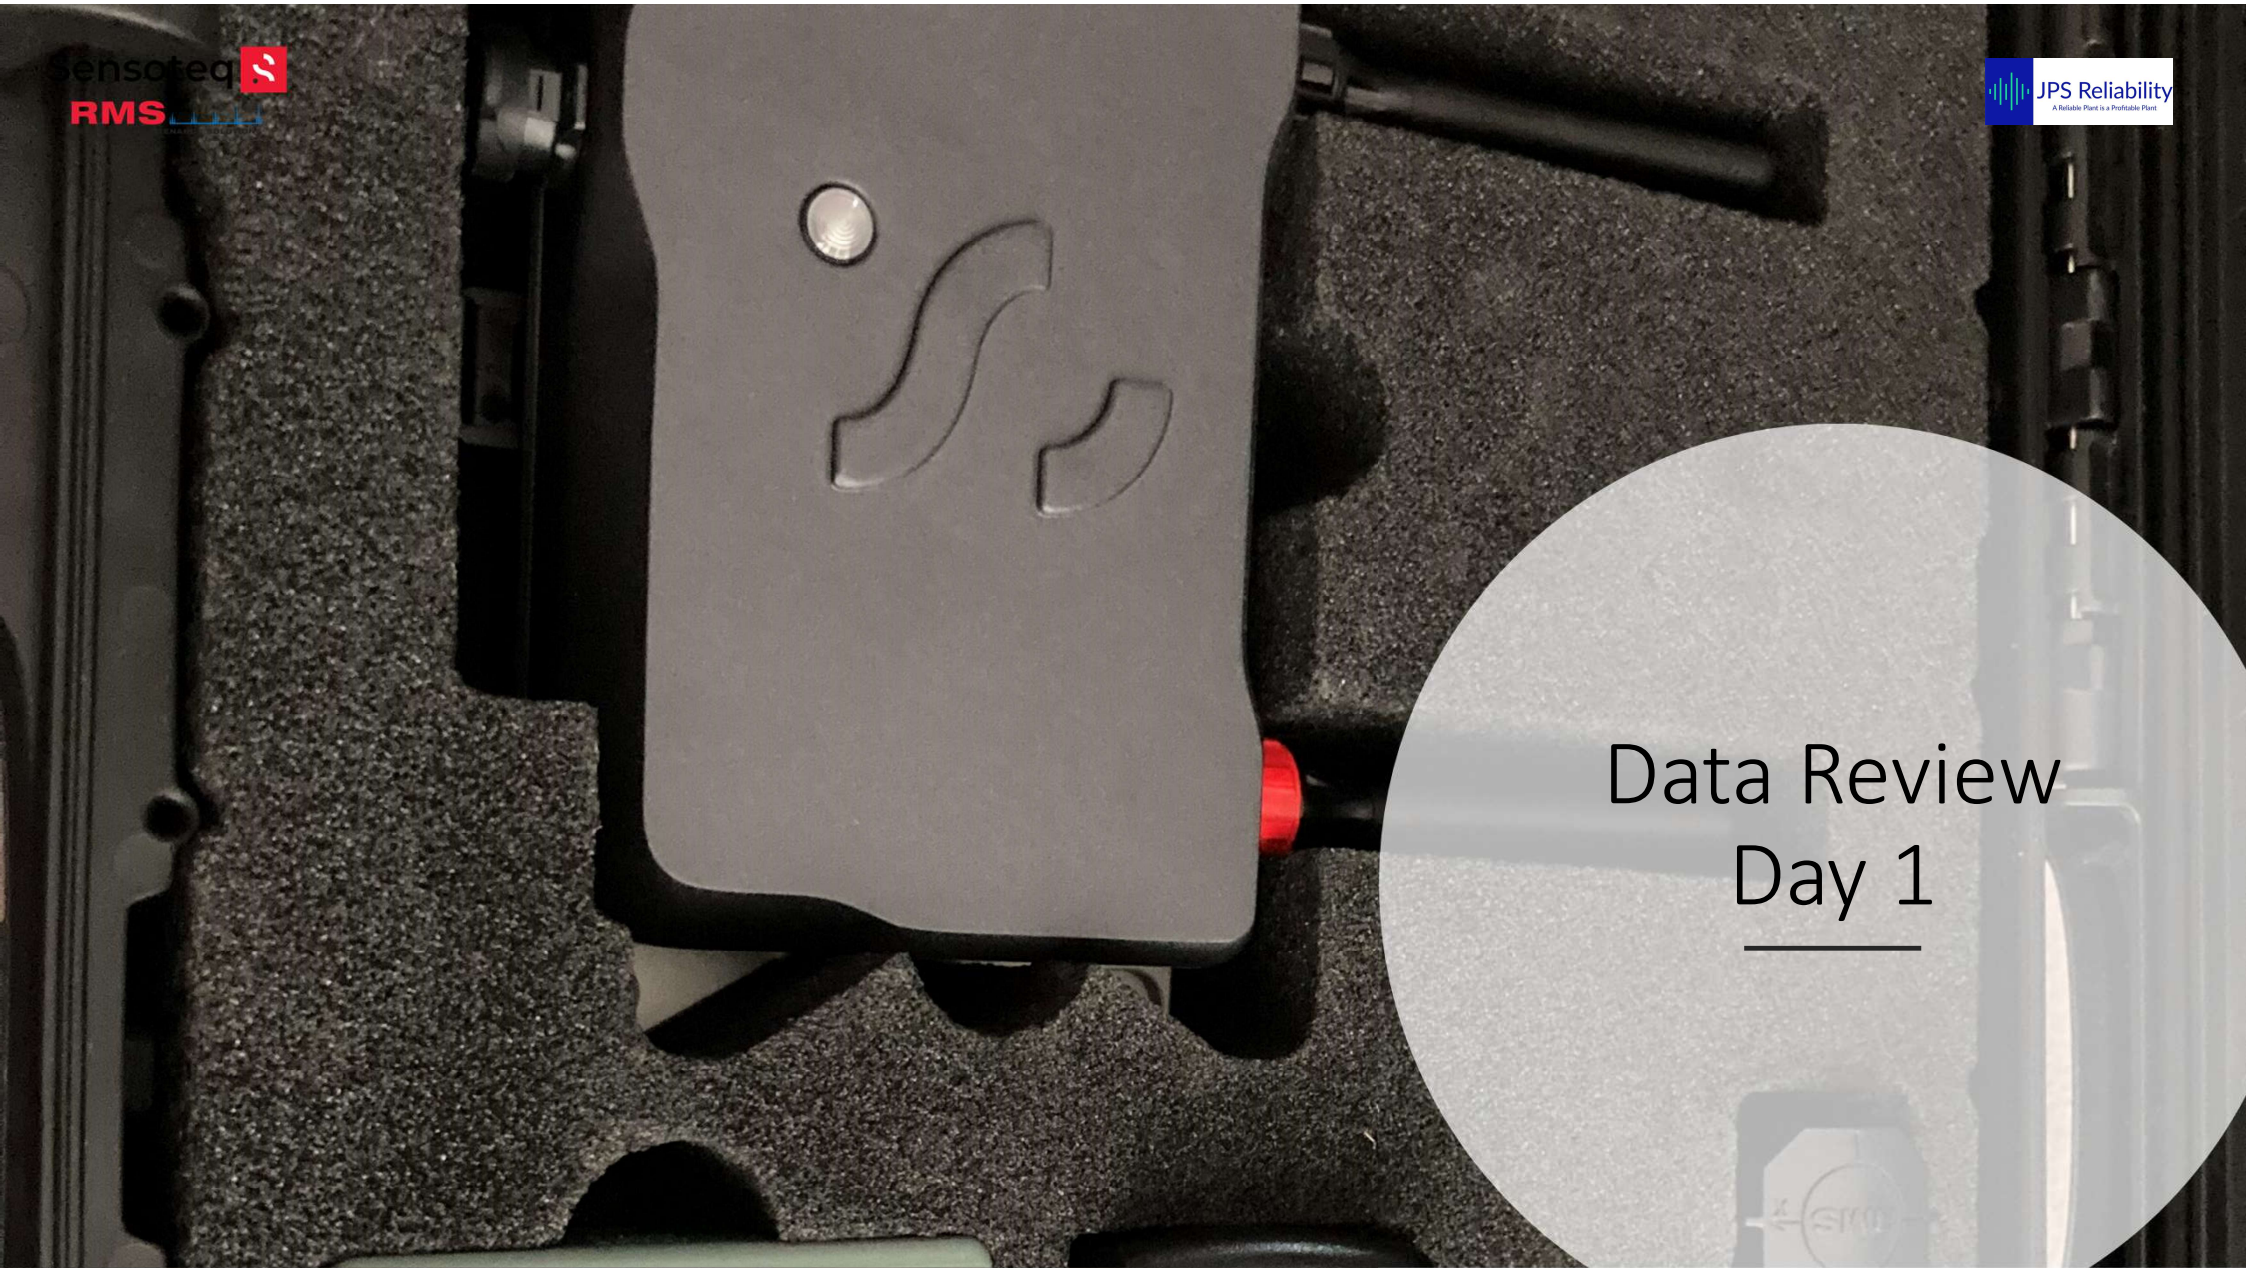
# Data Review Day 1

1. The wireless system is resolving the known motor electrical anomaly due to the variable speed drive operation.
2. The wireless system has highlighted a potential reliability issue with the fan NDE bearing.

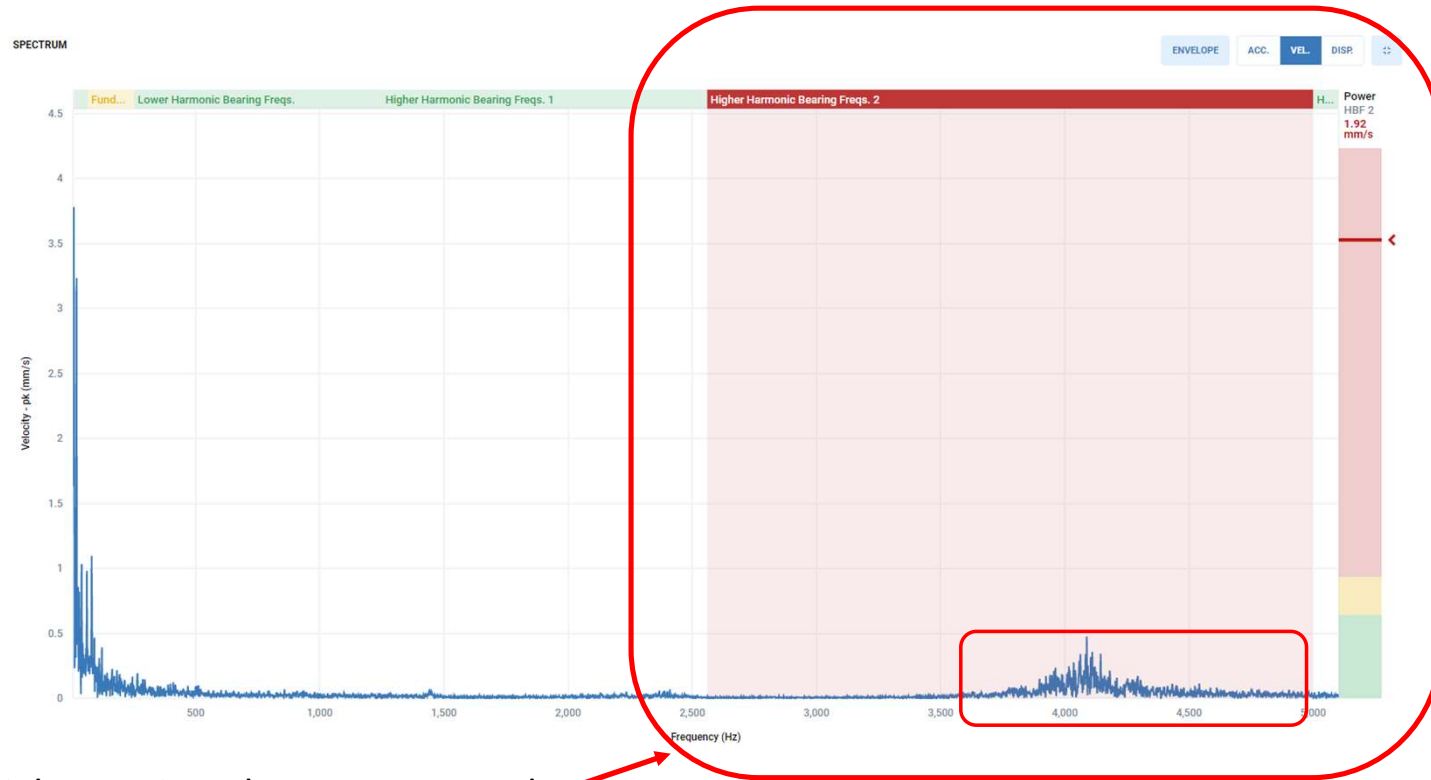
# Power Band Alarming in Velocity

Critical - vibration power (low res) alarm triggered!

High Warning Alarm Power Band

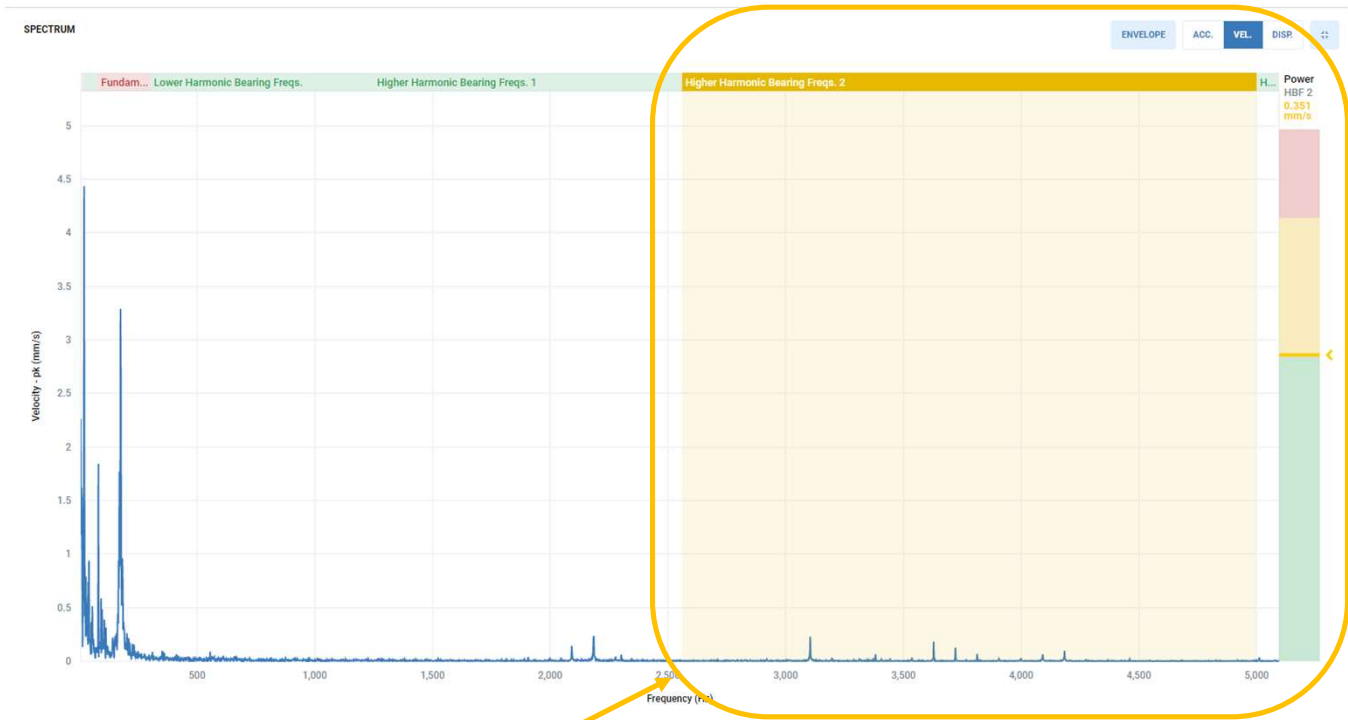
# Power Band Alarming in Velocity

**Warning** Warning - Axial vibration power (low res) exceeded band thresholds

Early Warning Alarm

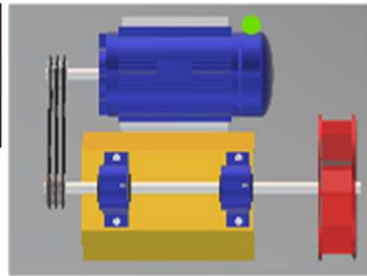
## MOTOR NDE

| Before Grease | After Grease |
|---|---|
| 46 dB's @ 25kHz | 46 dB's @ 25kHz |

No change in the dB on greasing – No change in the VA data

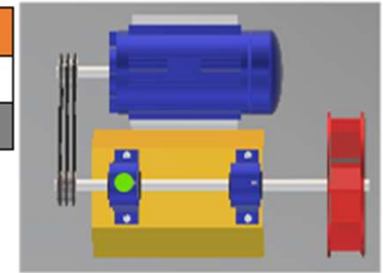
## FAN DE BRG

| Before Grease | After Grease |
|---|---|
| 58 dB's @ 22kHz | 44 dB's @ 22kHz |

58dB to 34dB on greasing – Drop in the VA data

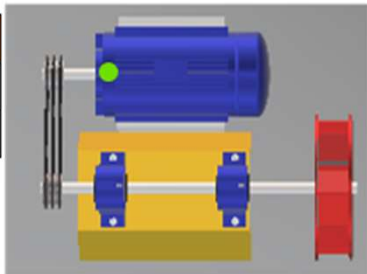
## MOTOR DE

| Before Grease | After Grease |
|---|---|
| 43 dB's @ 25kHz | 33 dB's @ 25kHz |

43dB to 33dB on greasing – Slight temporary change in the VA data

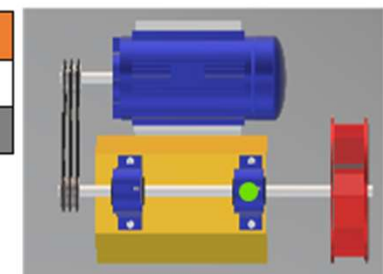
## FAN NDE BRG

| Before Grease | After Grease |
|---|---|
| 53 dB's @ 22kHz | 34 dB's @ 22kHz |

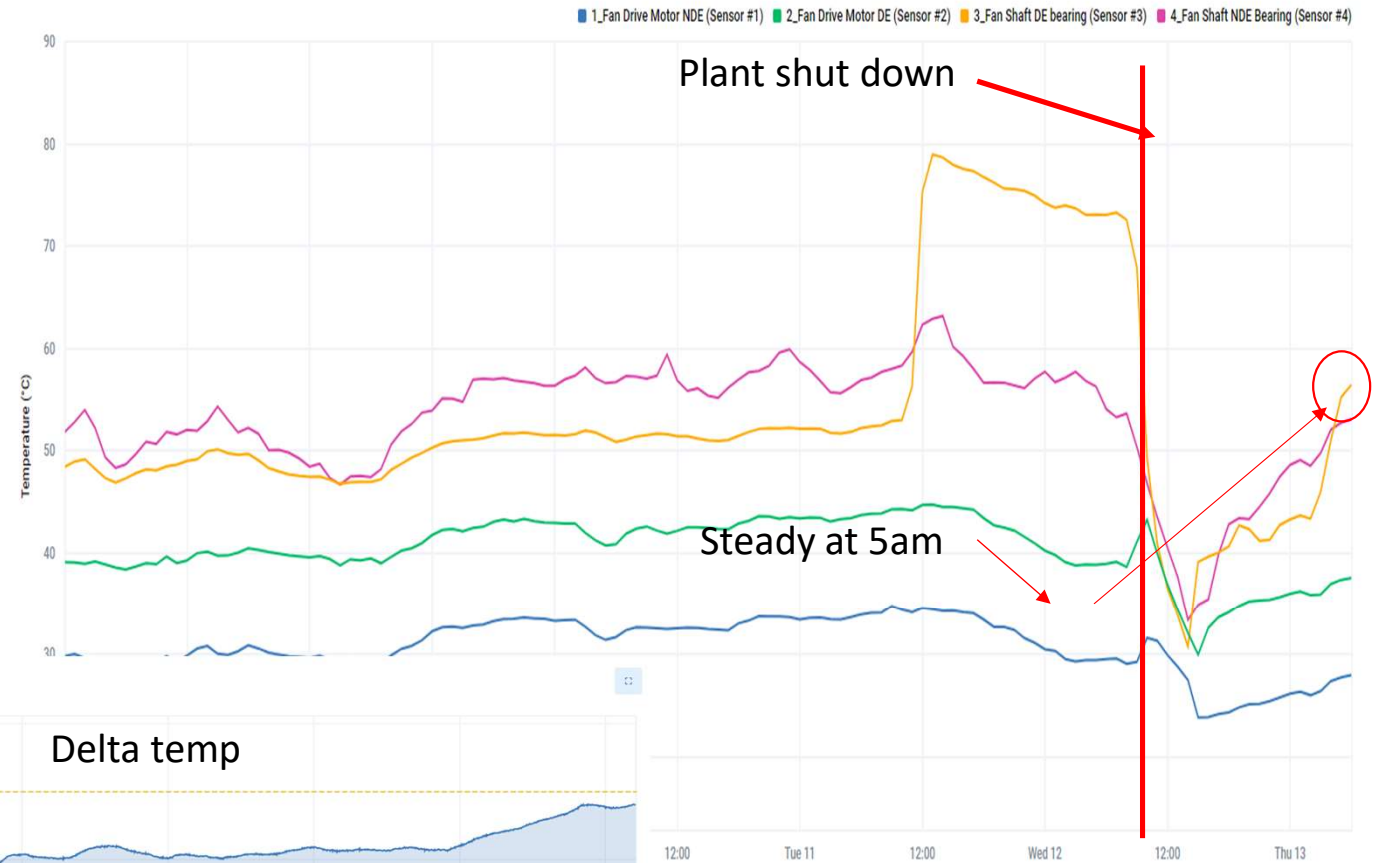
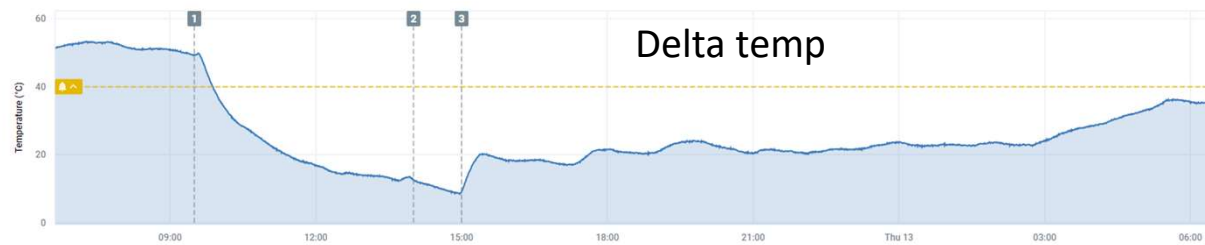
- 12 hours after start-up
- NDE temperature levels remains lower
- DE did peak and then return steady at 5am

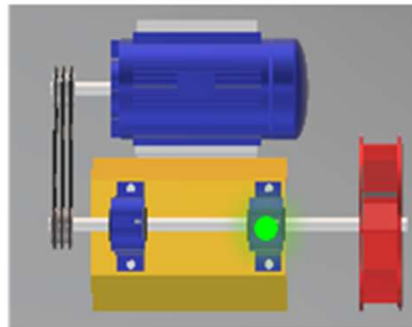
Fan NDE

| 12/01/22 | 13/01/22 |
|---|---|
| 34 dB's @ 22kHz | 53/57dB @ 22KHz |

- The first on the run greasing of the fan bearings had very little affect on the NDE, on the DE it reduced but the bearing temperature increased
- After bearing inspection it was found that both bearings were packed with old grease, this was removed
- After re-pack the NDE was at the lowest recorded levels, the DE however increased but then reduced back dow (probably as the grease was moving/settling in the bearing)
- Further controlled greasing of the DE fan bearing only

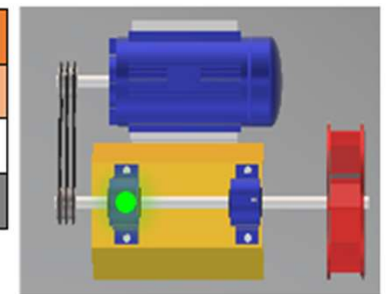
Fan DE

| 12/01/22 | 13/01/22 | 13/01/22 |
|---|---|---|
| 44 dB @ 22kHz | 47/49Kdb @ 22KHz | 35dB @ 22KHz |

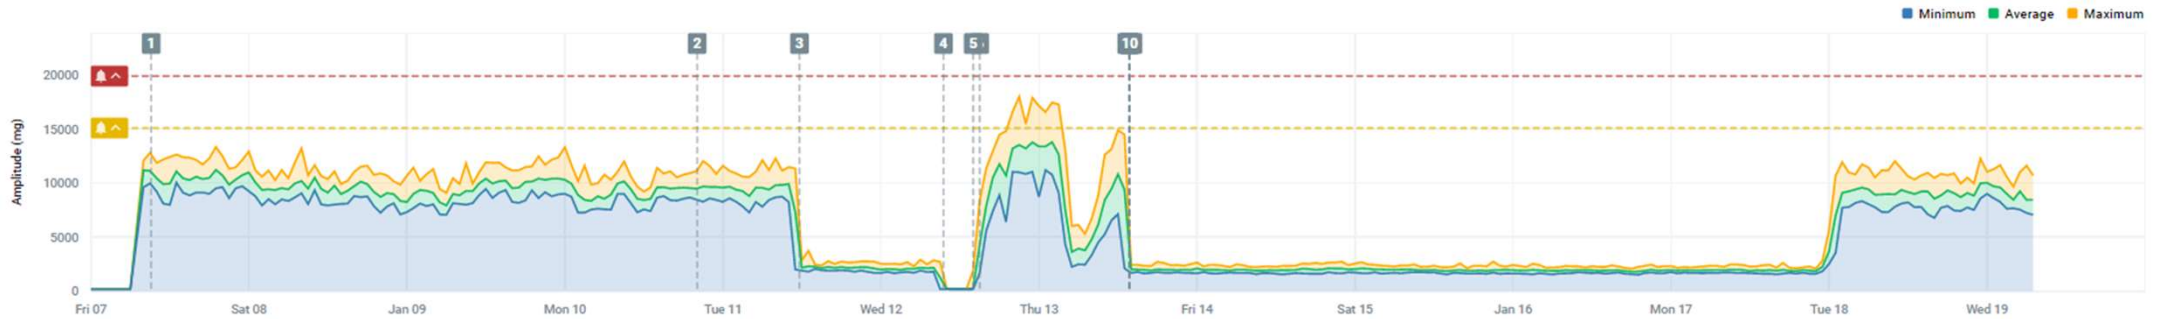
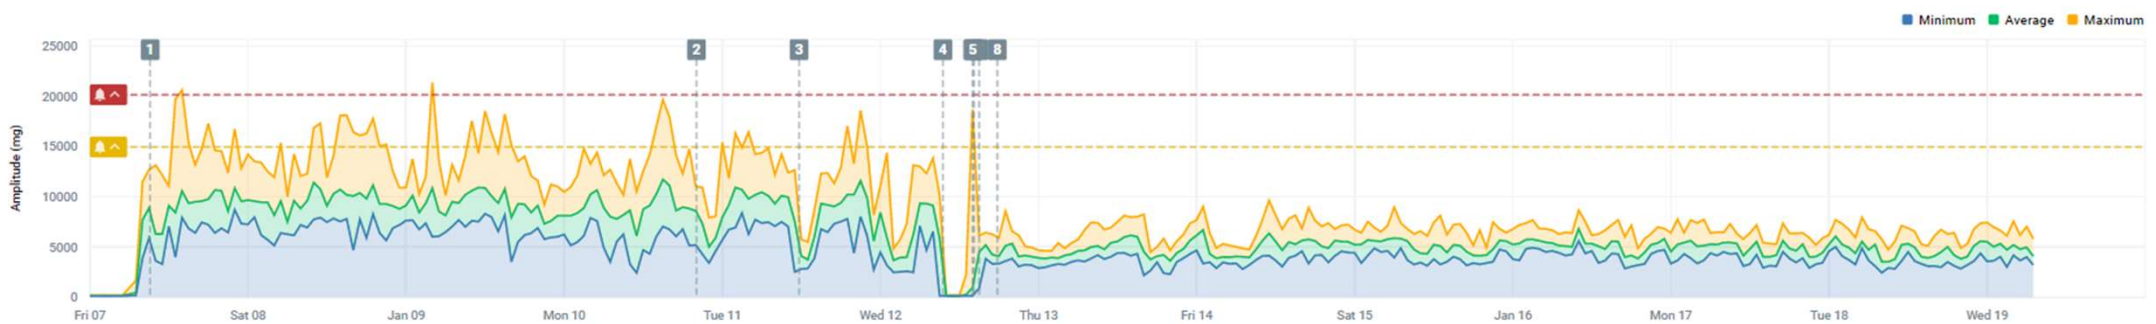
# Fan DE and NDE Pk-Pk Acceleration Long Time Trends

Fan: The Fan NDE bearing shows signs of general bearing wear. Corrective actions has helped to reduce the bearing stress levels.

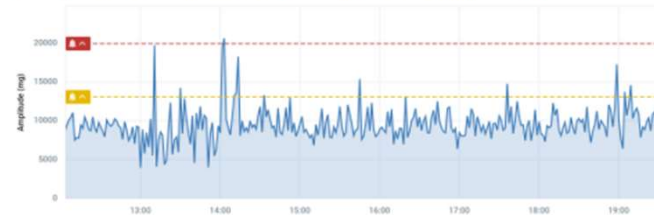
BL2 Dryer Fan Zone 1 right hand side - 4\_Fan Shaft NDE Bearing (Sensor #4) - Peak-to-Peak

On initial data set up a possible defect has been detected at the fan NDE bearing.

In comparisons this is the fan NDE bearing with an elevated level of 8gs and random peaks to 20gs

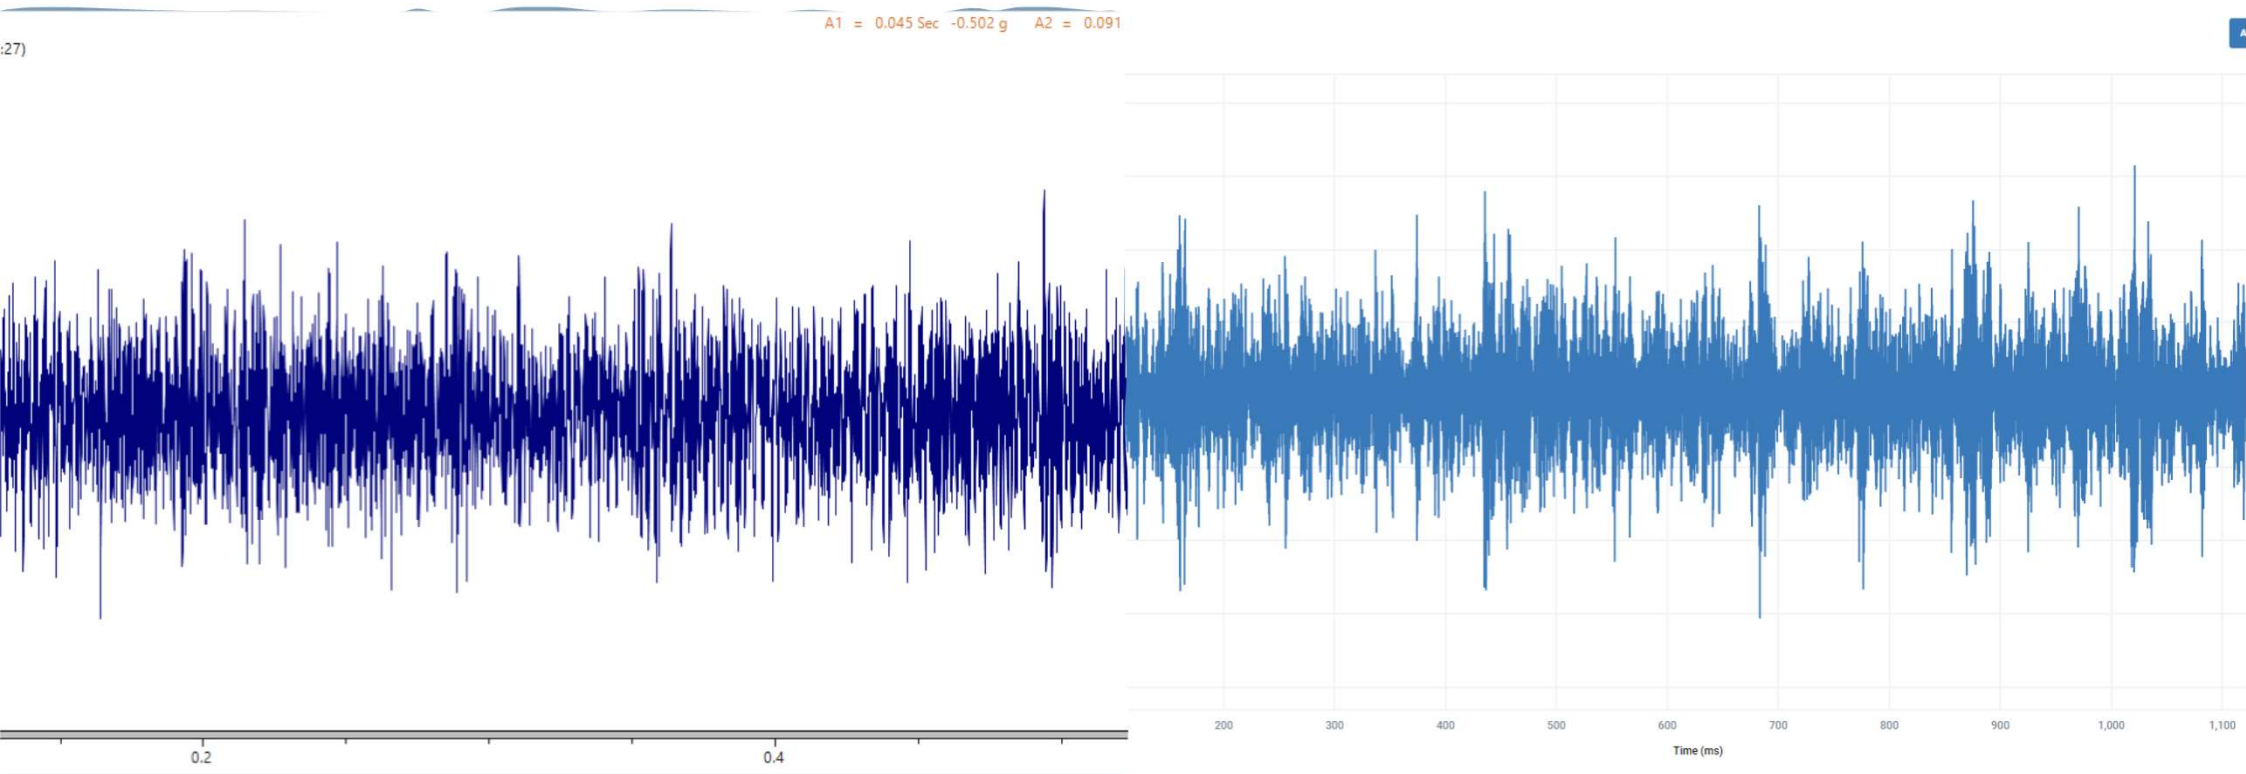
# Fan NDE Data Comparisons

Handheld 11/01/2022 11:45 Manual

Sensoteq 11/01/2022 16:21 Automatic
